Construction in Photos

March 17 - 24, 2016

Water Resource Recovery Department Village of Ashville Ashville's Water Resource Recovery Facility Part A

Ashville's Water Resource Recover Facility Project Planning Timeline 2015 - 17

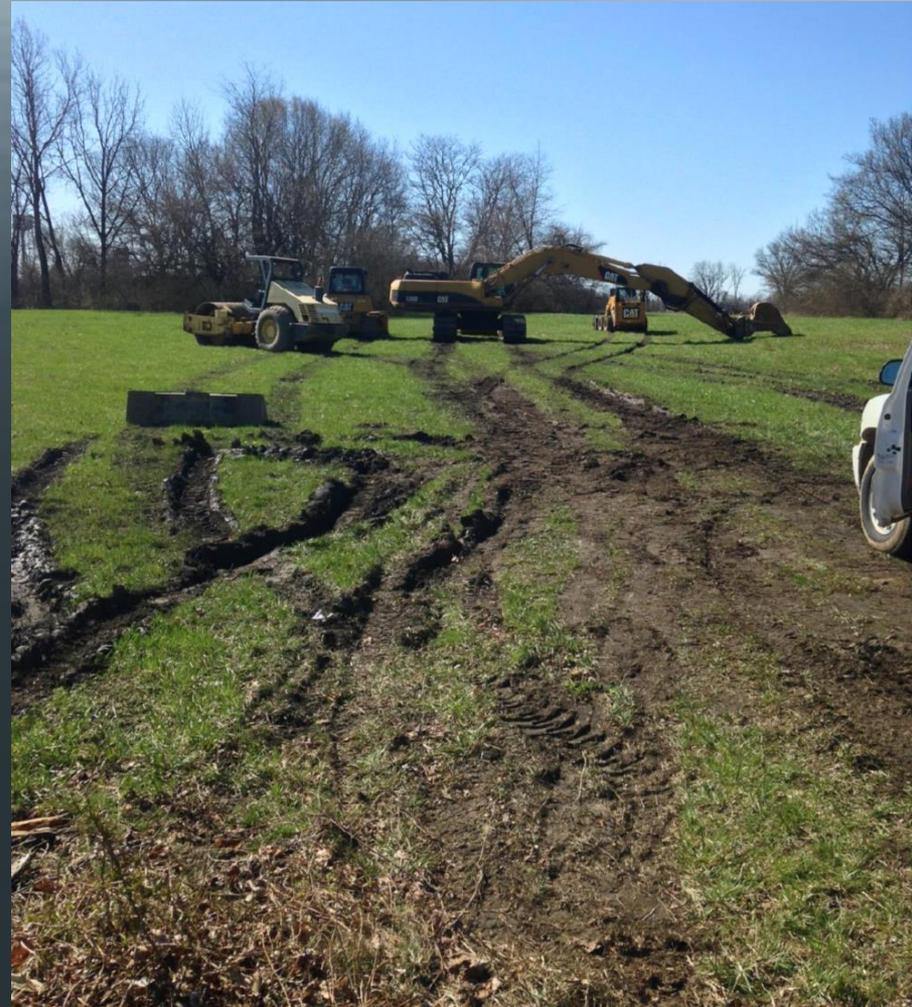
- March 17, 2016
- State Route 752 Plant Access Drive Site Conditions
- Job No: 60440011

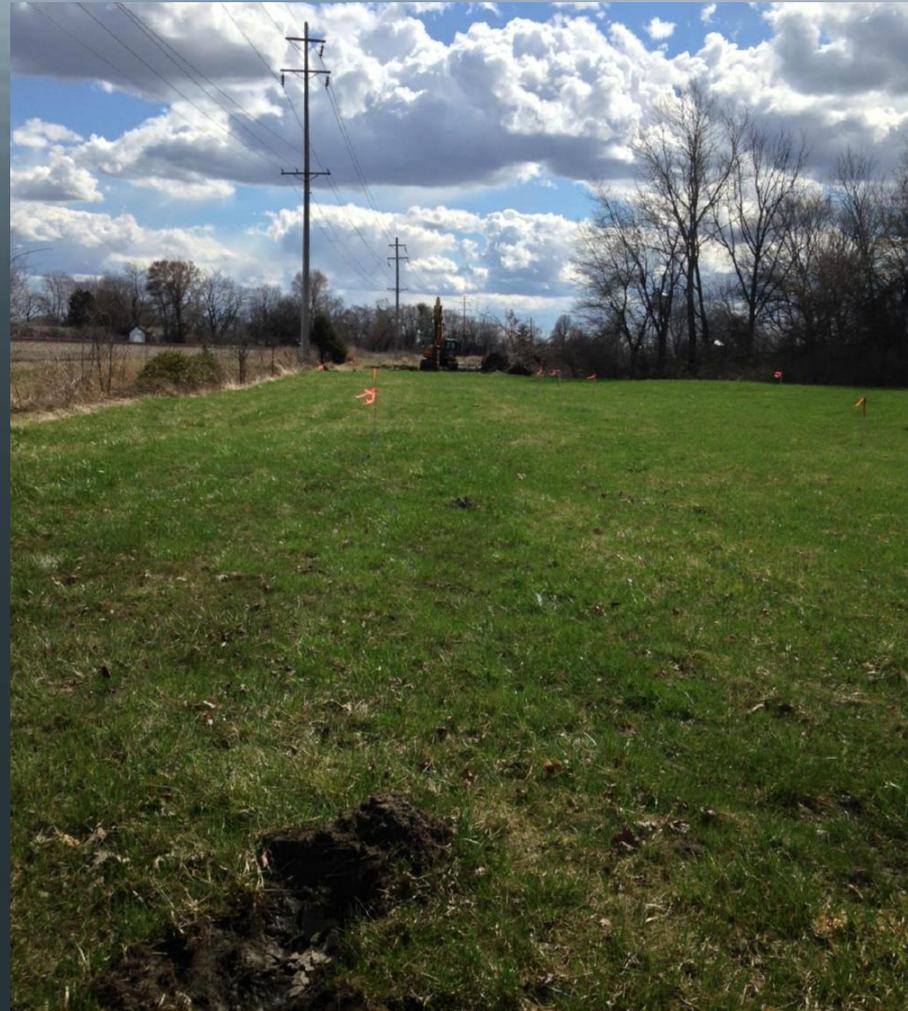
- March 17, 2016
- Surveying - 3 ft. Offset grade stakes spaced 100 ft. apart on both sides of drive
- Job No: 60440011

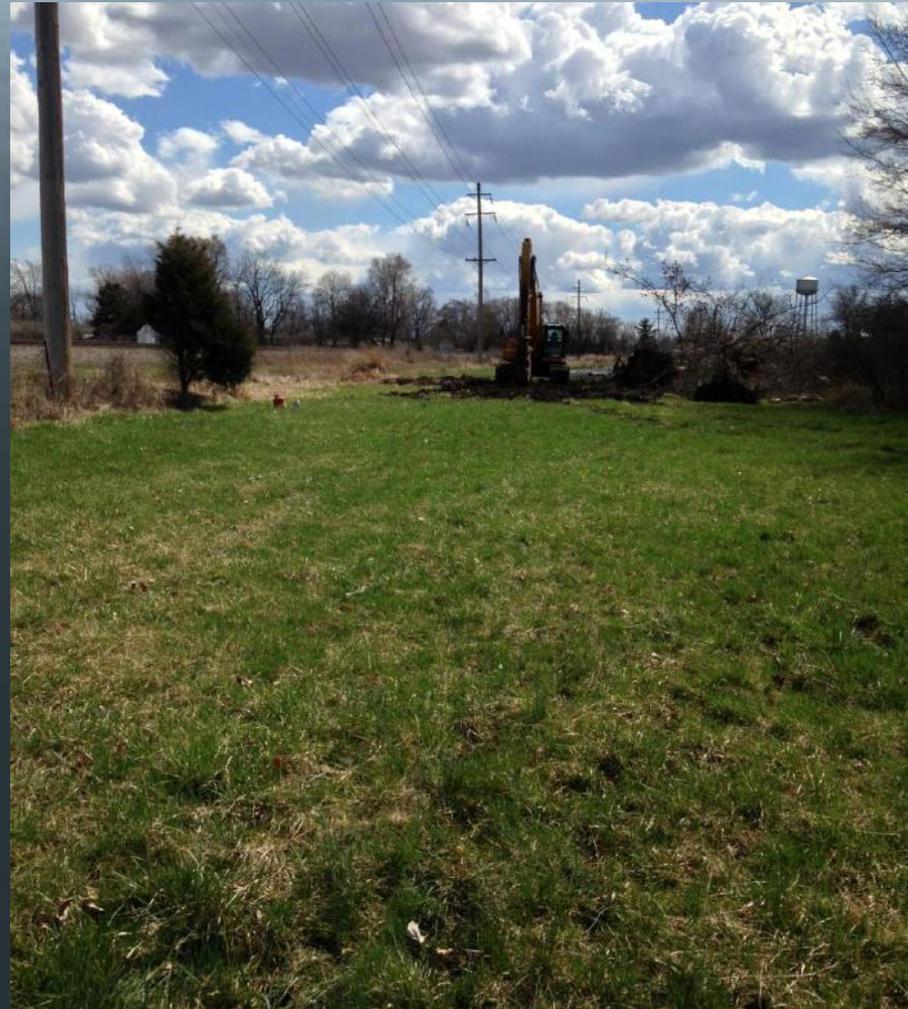
- March 17, 2016
- Removing small group of trees blocking survey workers
- Job No: 60440011

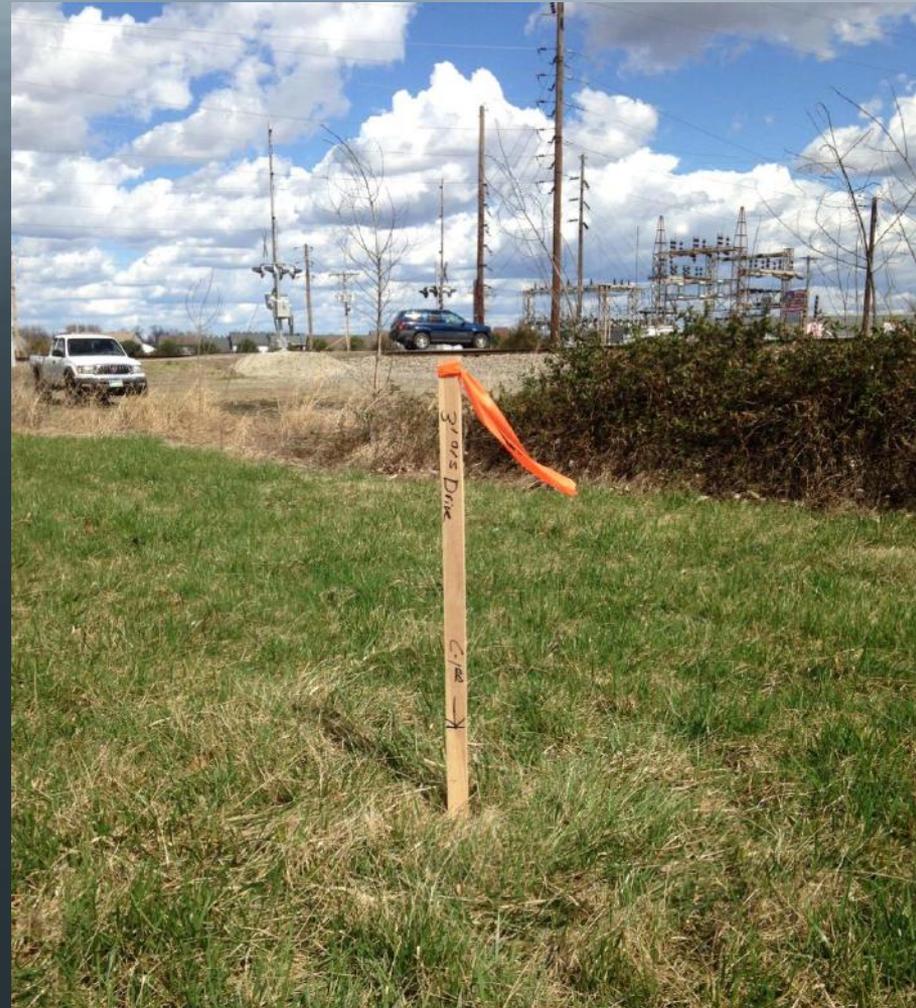
- March 17, 2016
- 3 ft. Offset grade stake showing top of gravel drive grade cut
- Job No: 60440011

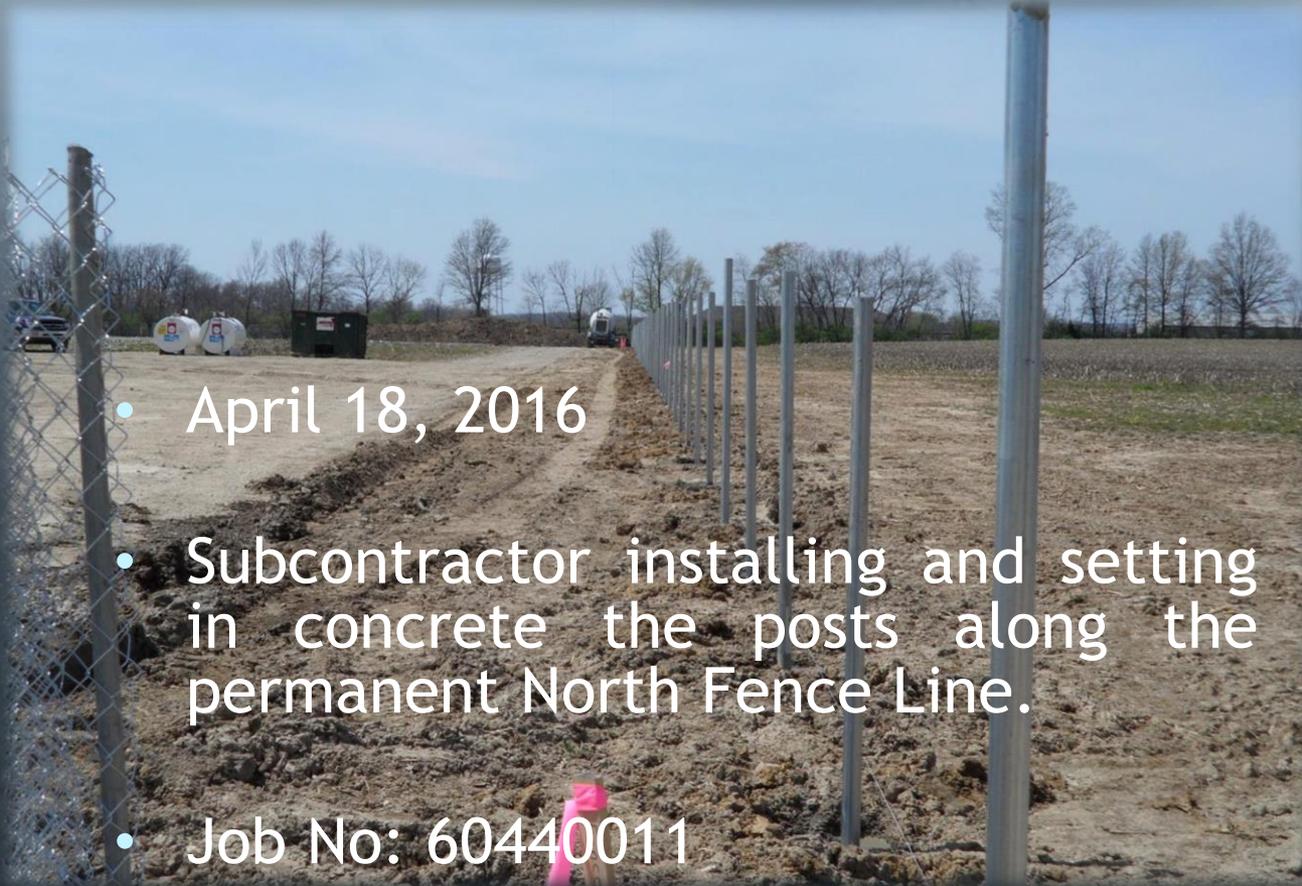
- April 18, 2016
- Subcontractor installing and setting in concrete the posts along the permanent North Fence Line.
- Job No: 60440011

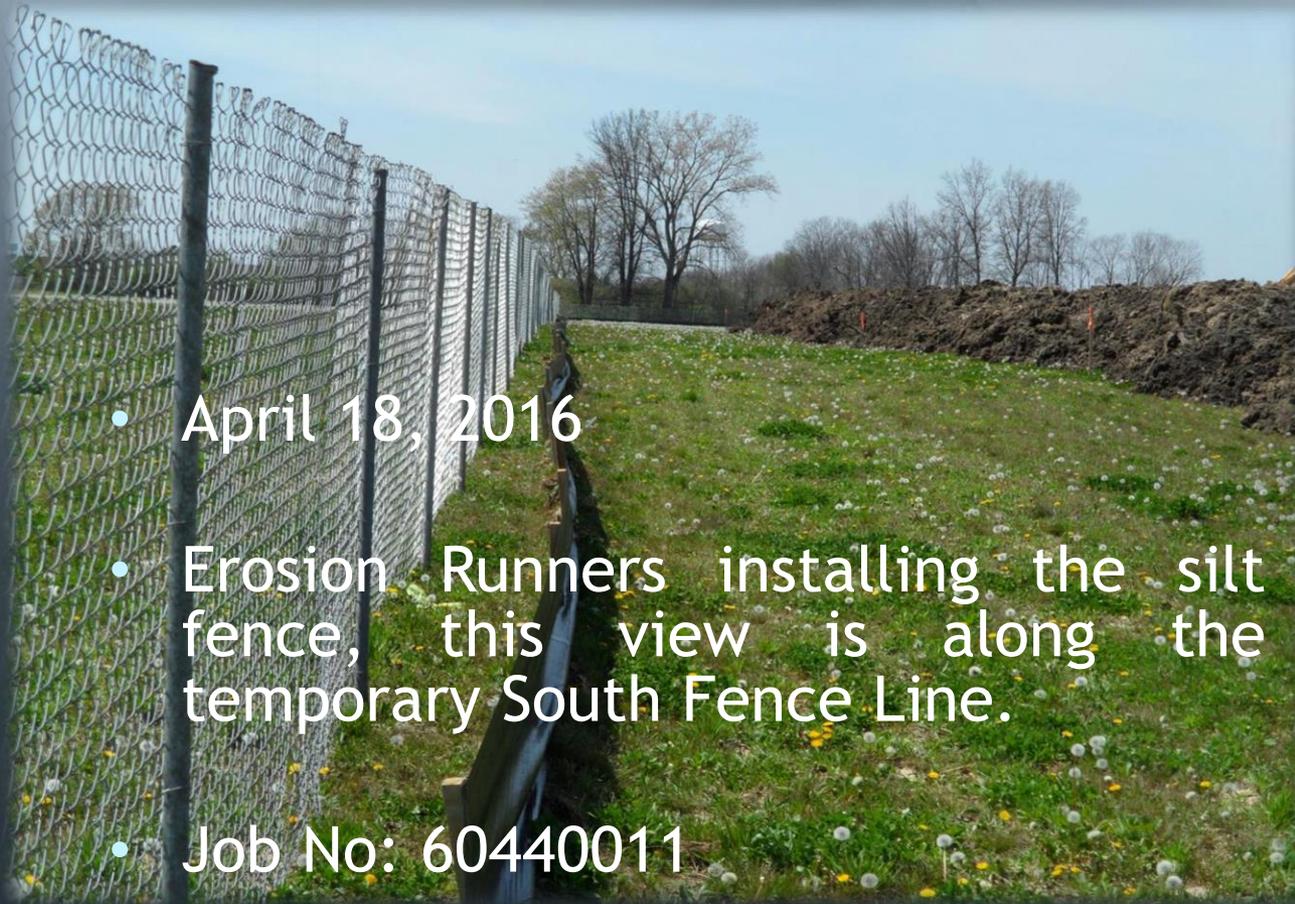
- April 18, 2016
- Erosion Runners installing the silt fence, this view is along the temporary South Fence Line.
- Job No: 60440011

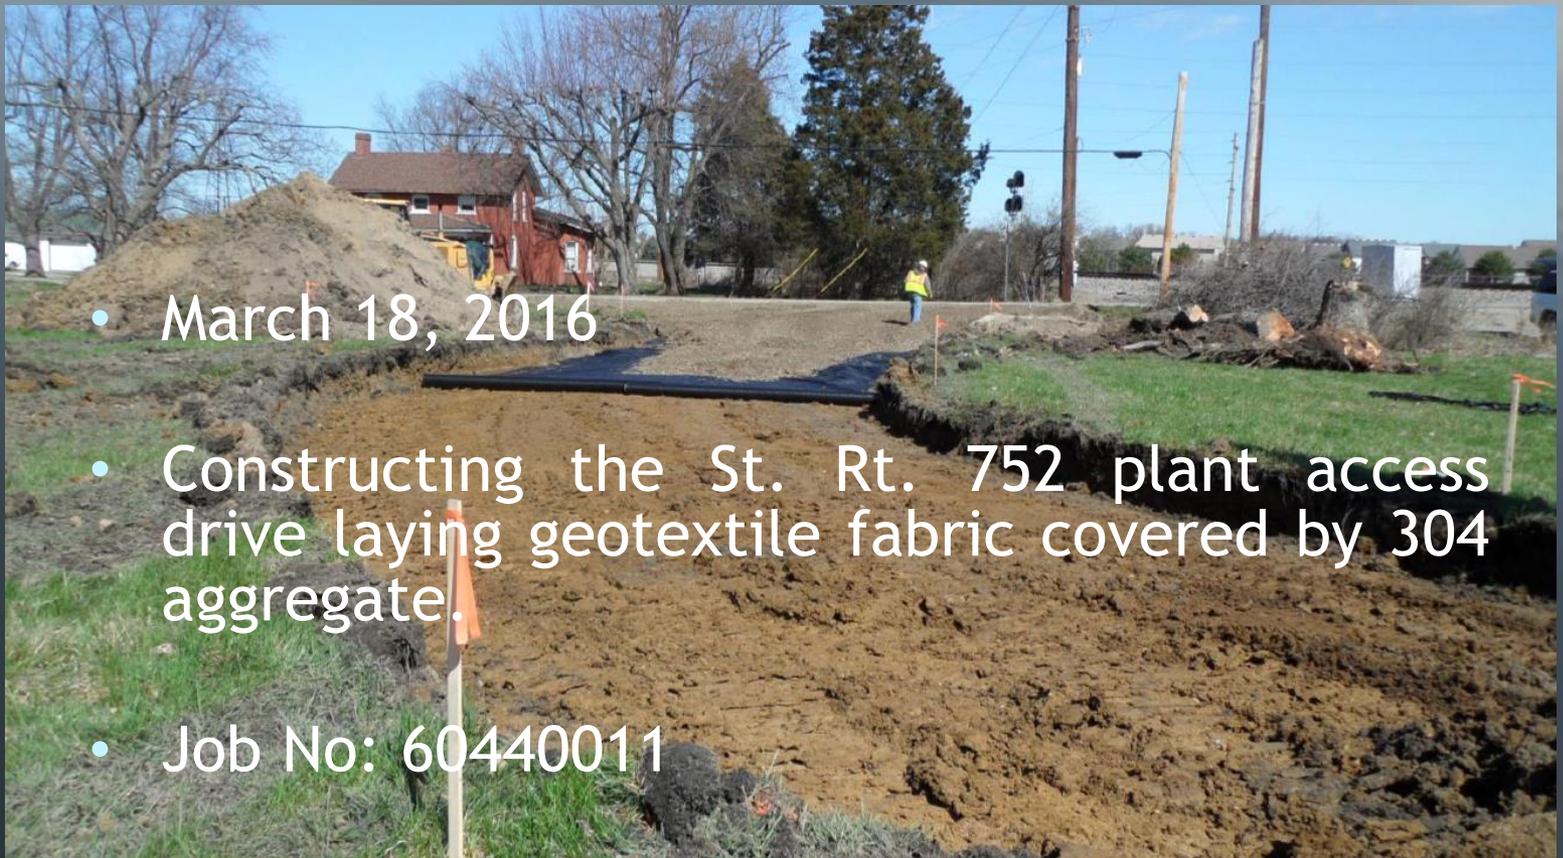
- March 18, 2016
- Constructing the St. Rt. 752 plant access drive laying geotextile fabric covered by 304 aggregate.
- Job No: 60440011

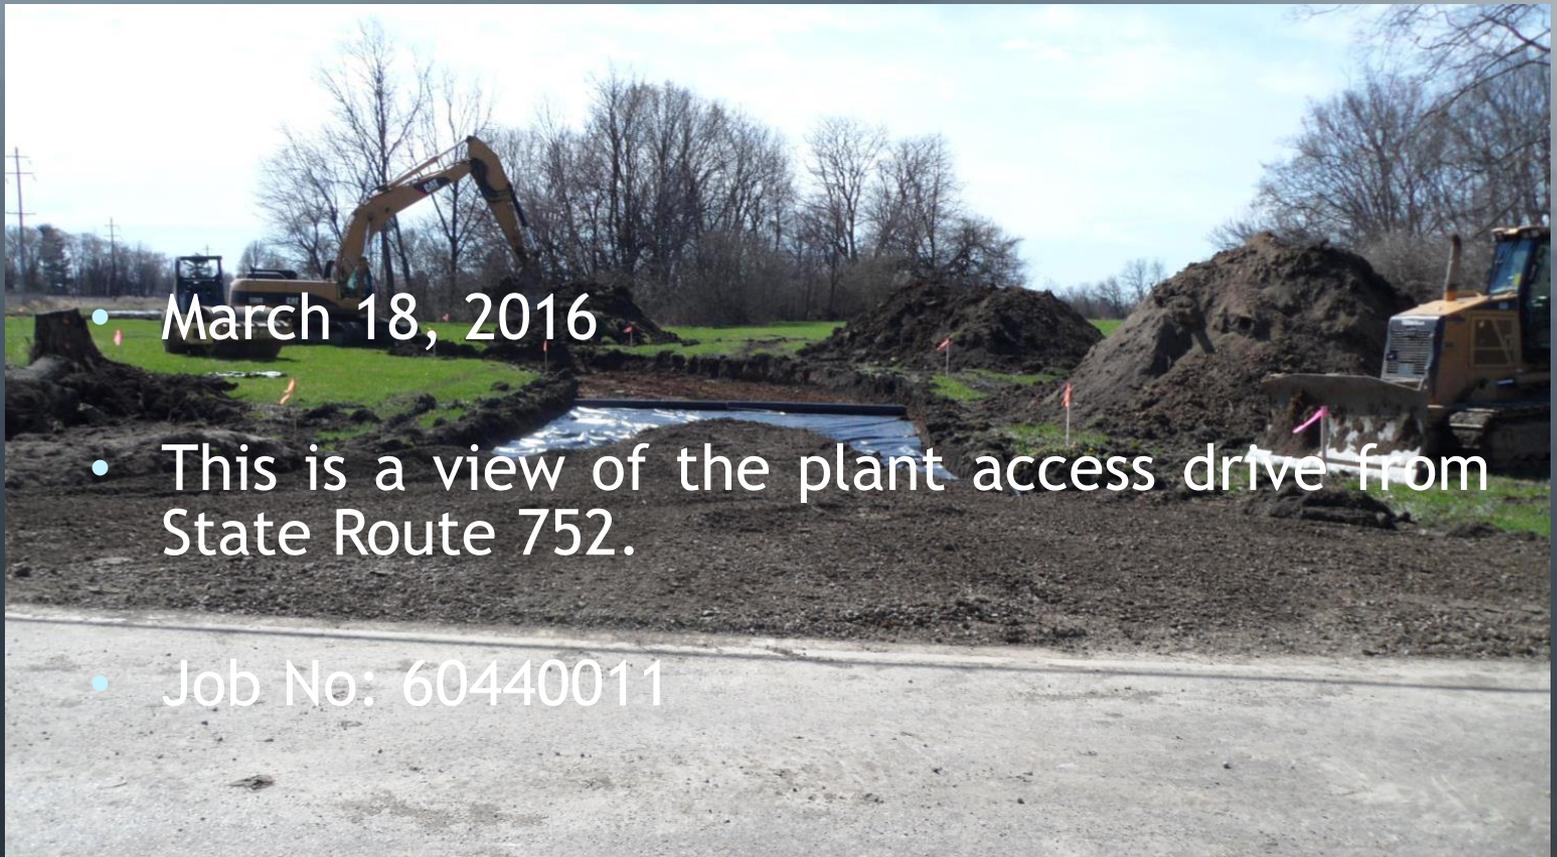
- March 18, 2016
- This is a view of the plant access drive from State Route 752.
- Job No: 60440011

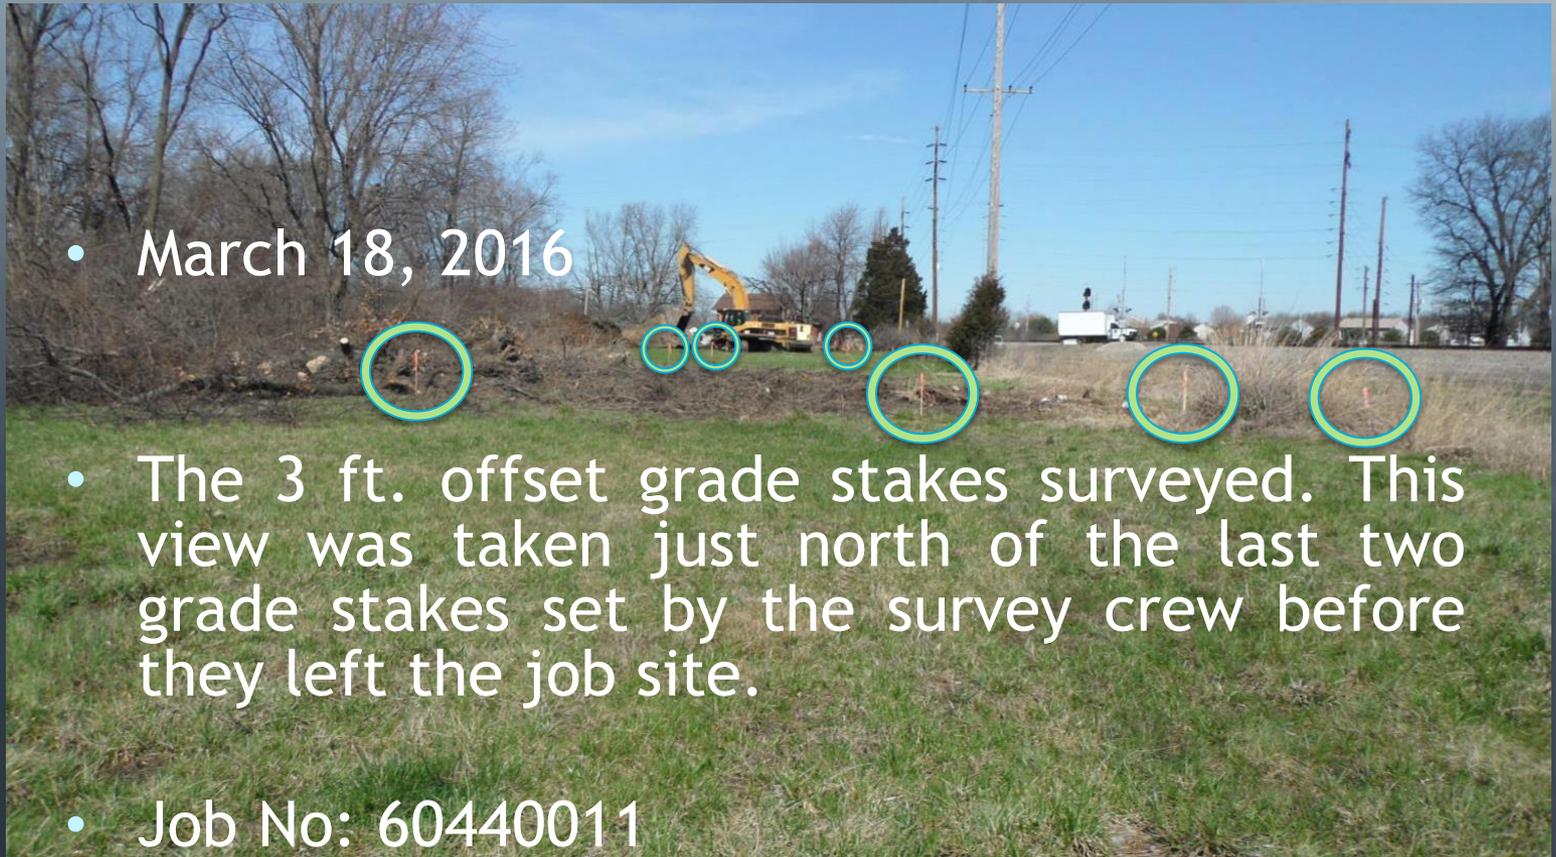
- March 18, 2016

- The 3 ft. offset grade stakes surveyed. This view was taken just north of the last two grade stakes set by the survey crew before they left the job site.

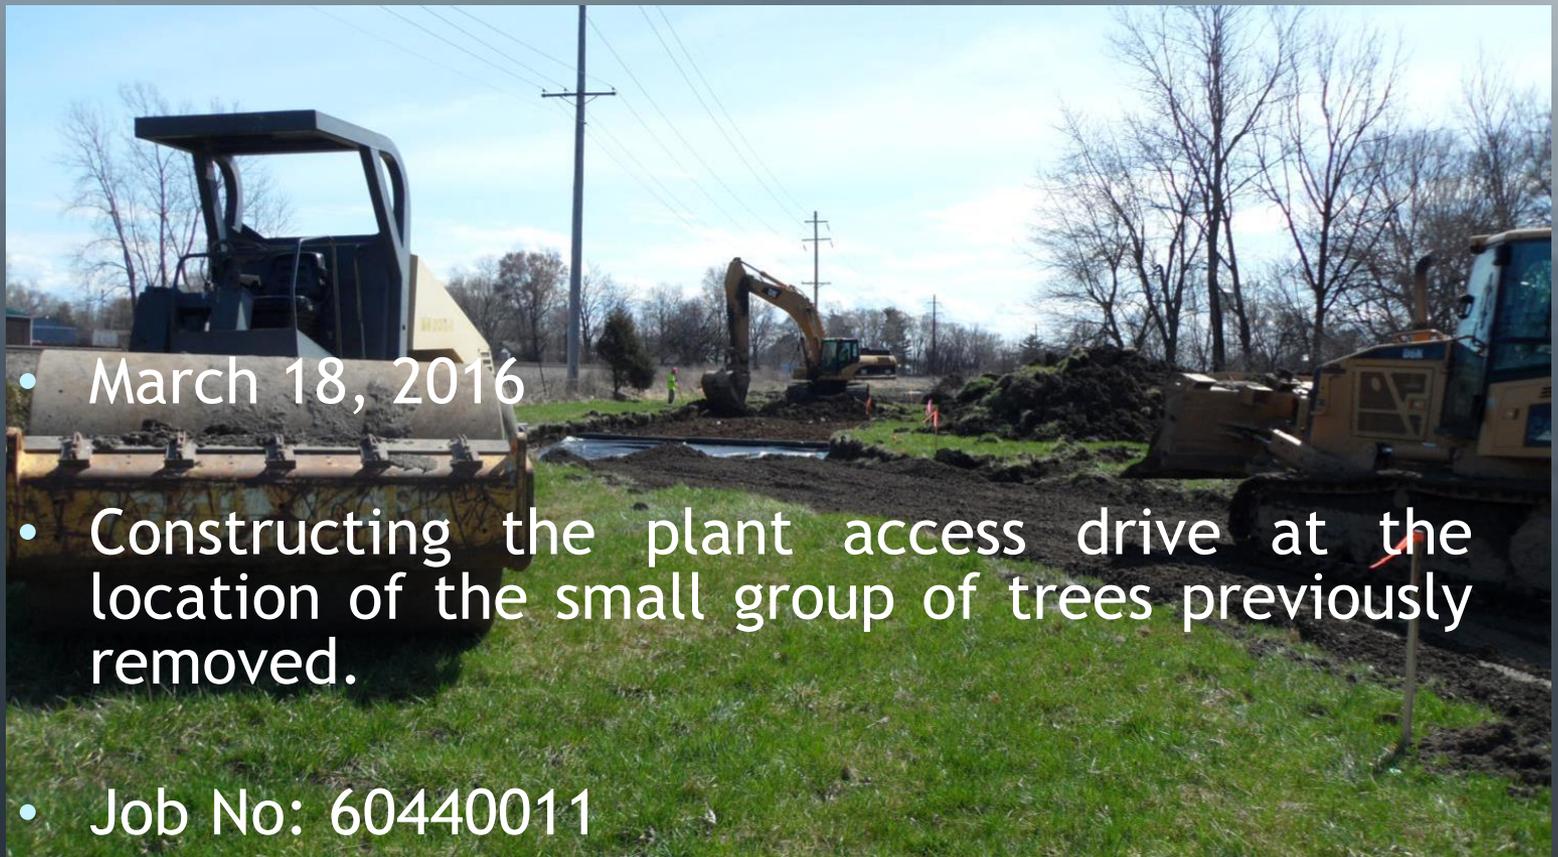
- March 18, 2016
- Constructing the plant access drive at the location of the small group of trees previously removed.
- Job No: 60440011

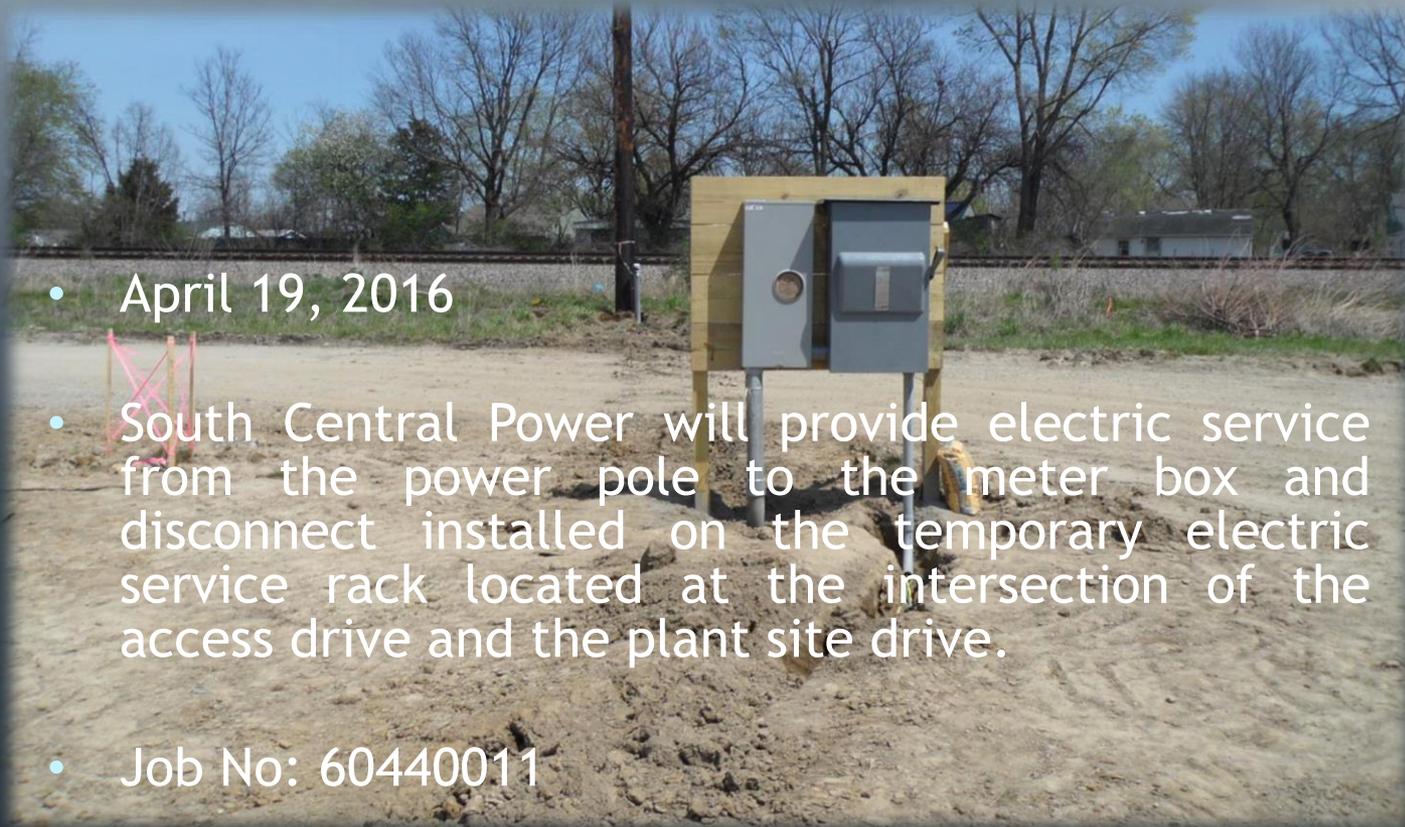
- April 19, 2016
- South Central Power will provide electric service from the power pole to the meter box and disconnect installed on the temporary electric service rack located at the intersection of the access drive and the plant site drive.
- Job No: 60440011

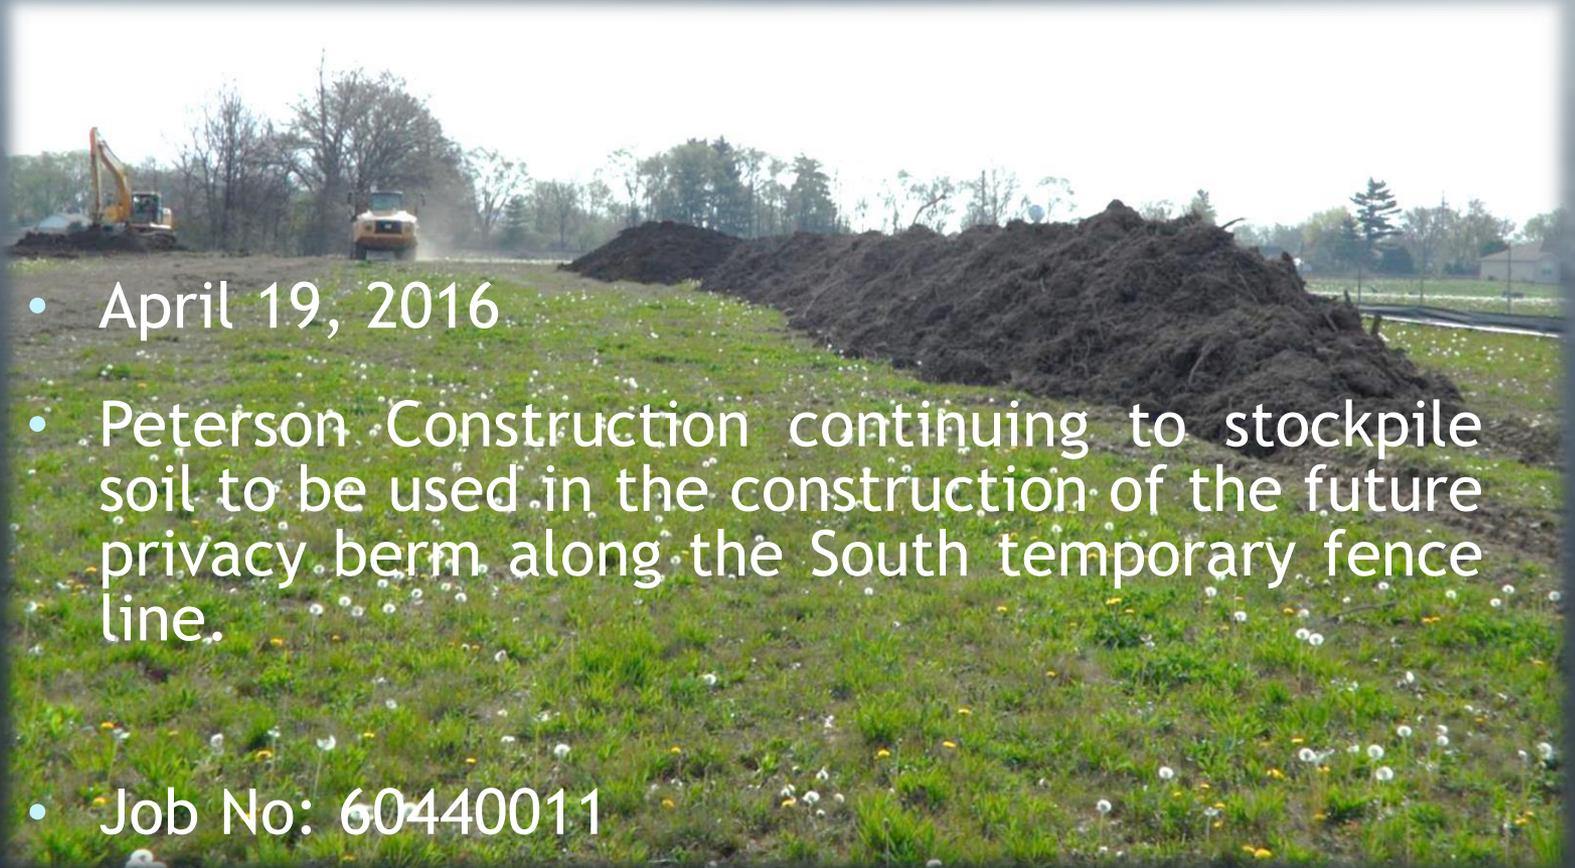
- April 19, 2016
- Peterson Construction continuing to stockpile soil to be used in the construction of the future privacy berm along the South temporary fence line.
- Job No: 60440011

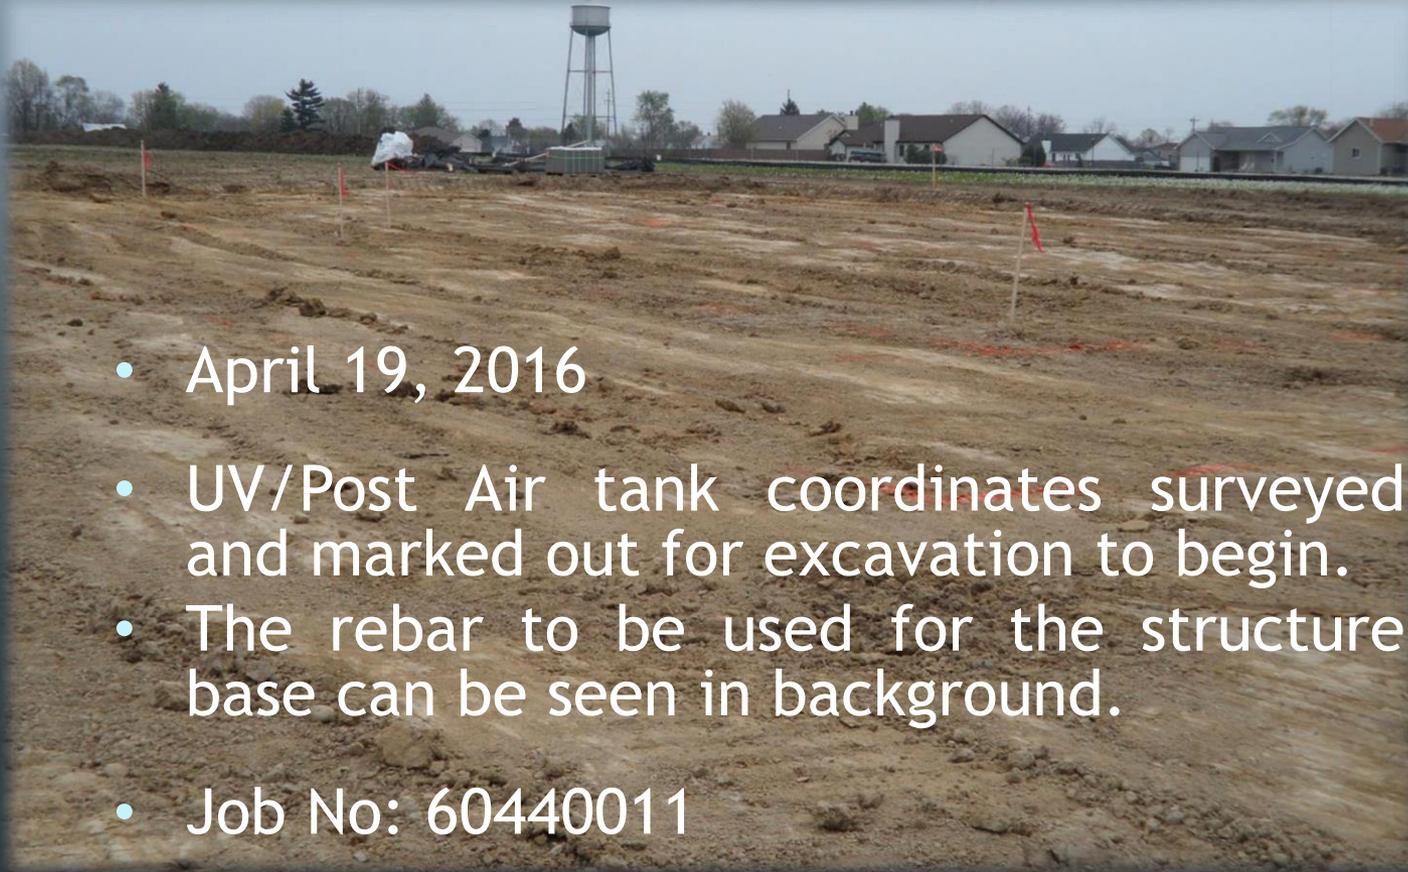
- April 19, 2016
- UV/Post Air tank coordinates surveyed and marked out for excavation to begin.
- The rebar to be used for the structure base can be seen in background.
- Job No: 60440011

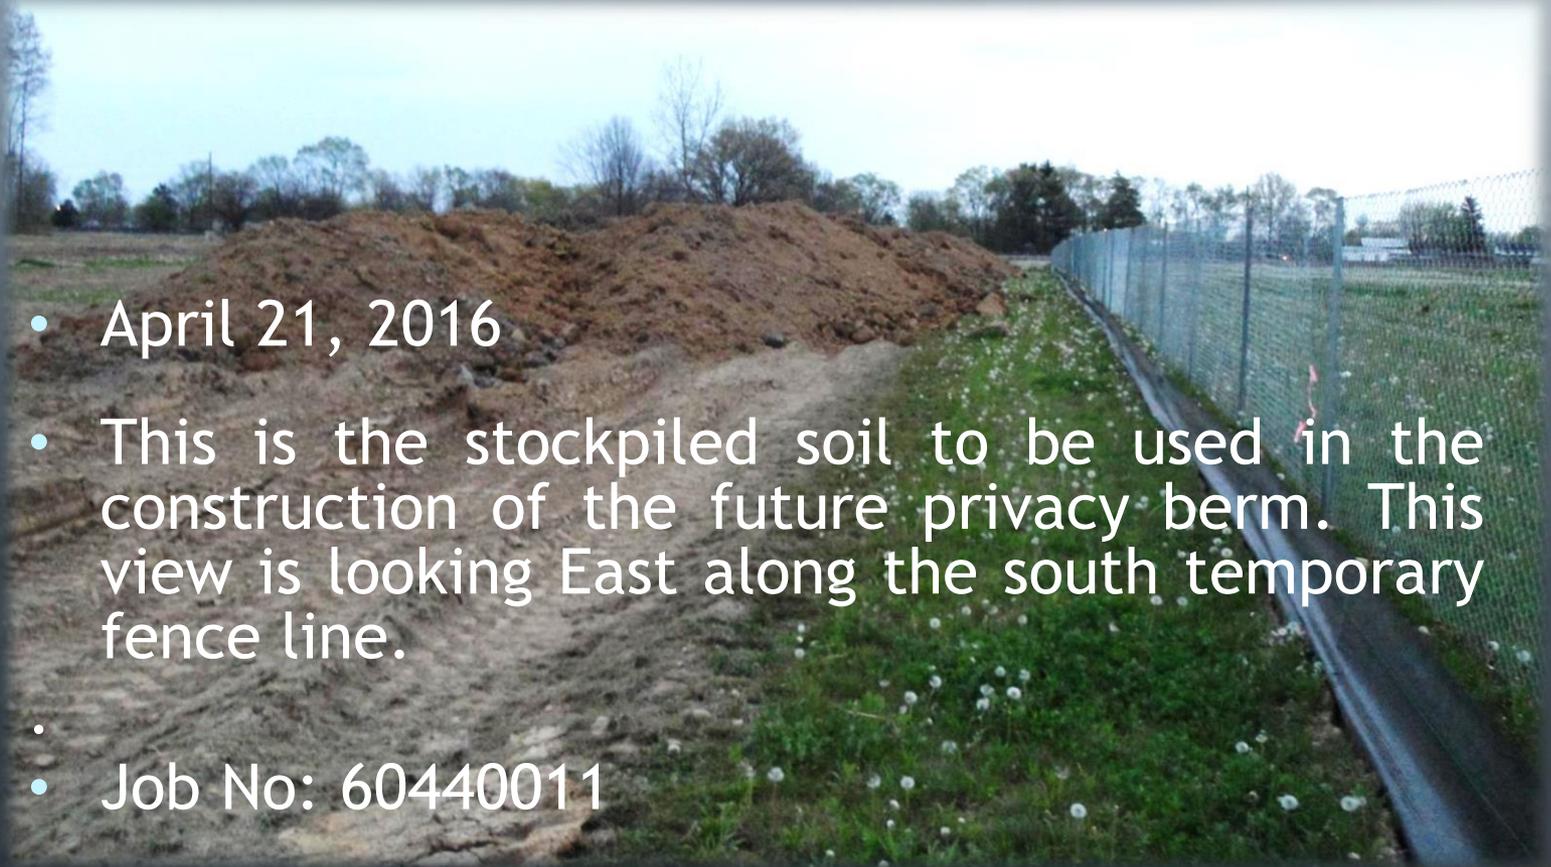
- April 21, 2016
- This is the stockpiled soil to be used in the construction of the future privacy berm. This view is looking East along the south temporary fence line.
- Job No: 60440011

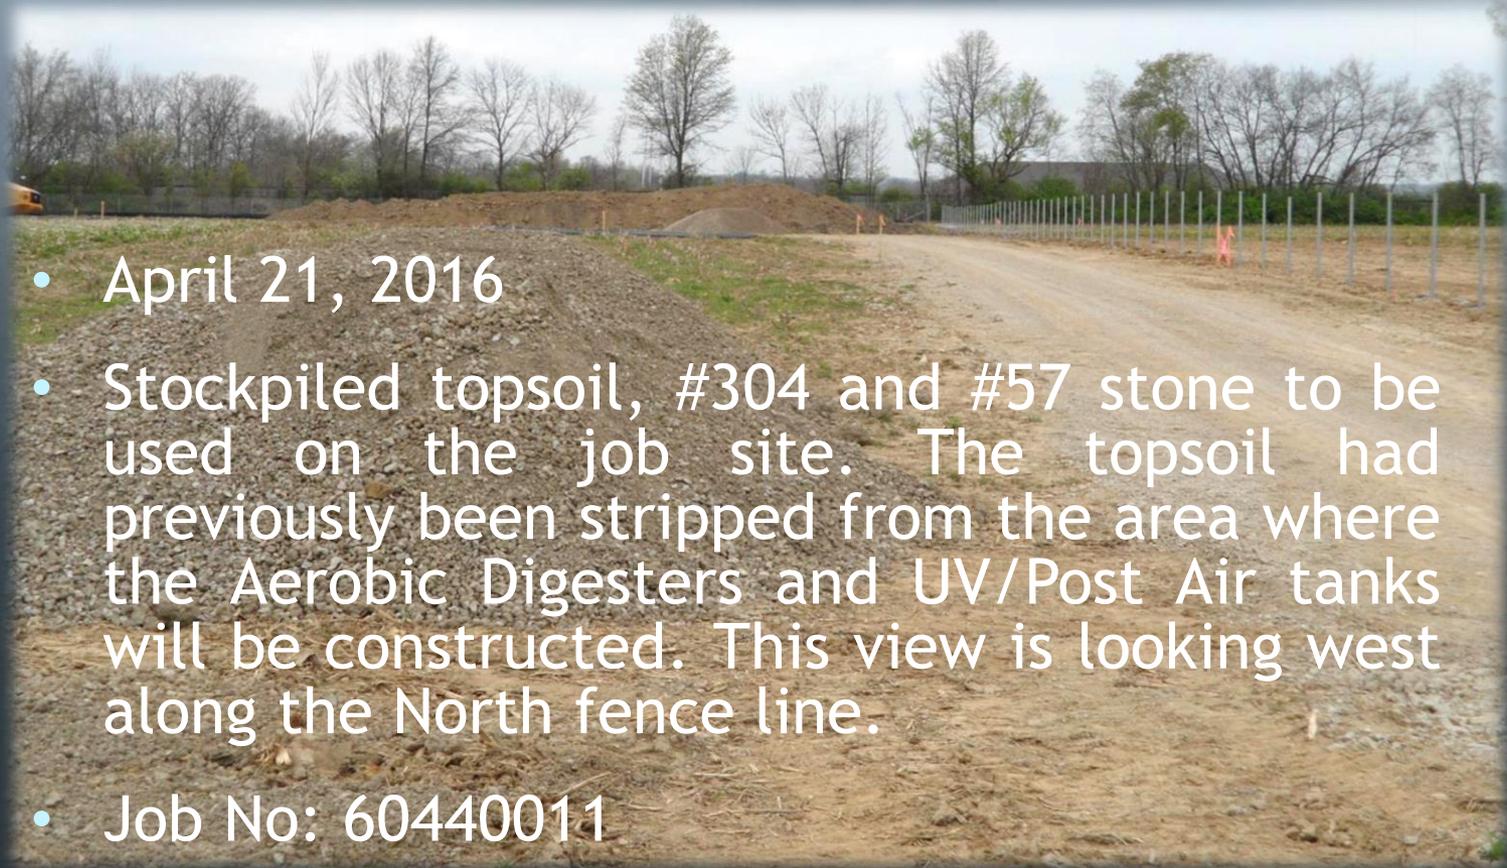
- April 21, 2016
- Stockpiled topsoil, #304 and #57 stone to be used on the job site. The topsoil had previously been stripped from the area where the Aerobic Digesters and UV/Post Air tanks will be constructed. This view is looking west along the North fence line.
- Job No: 60440011

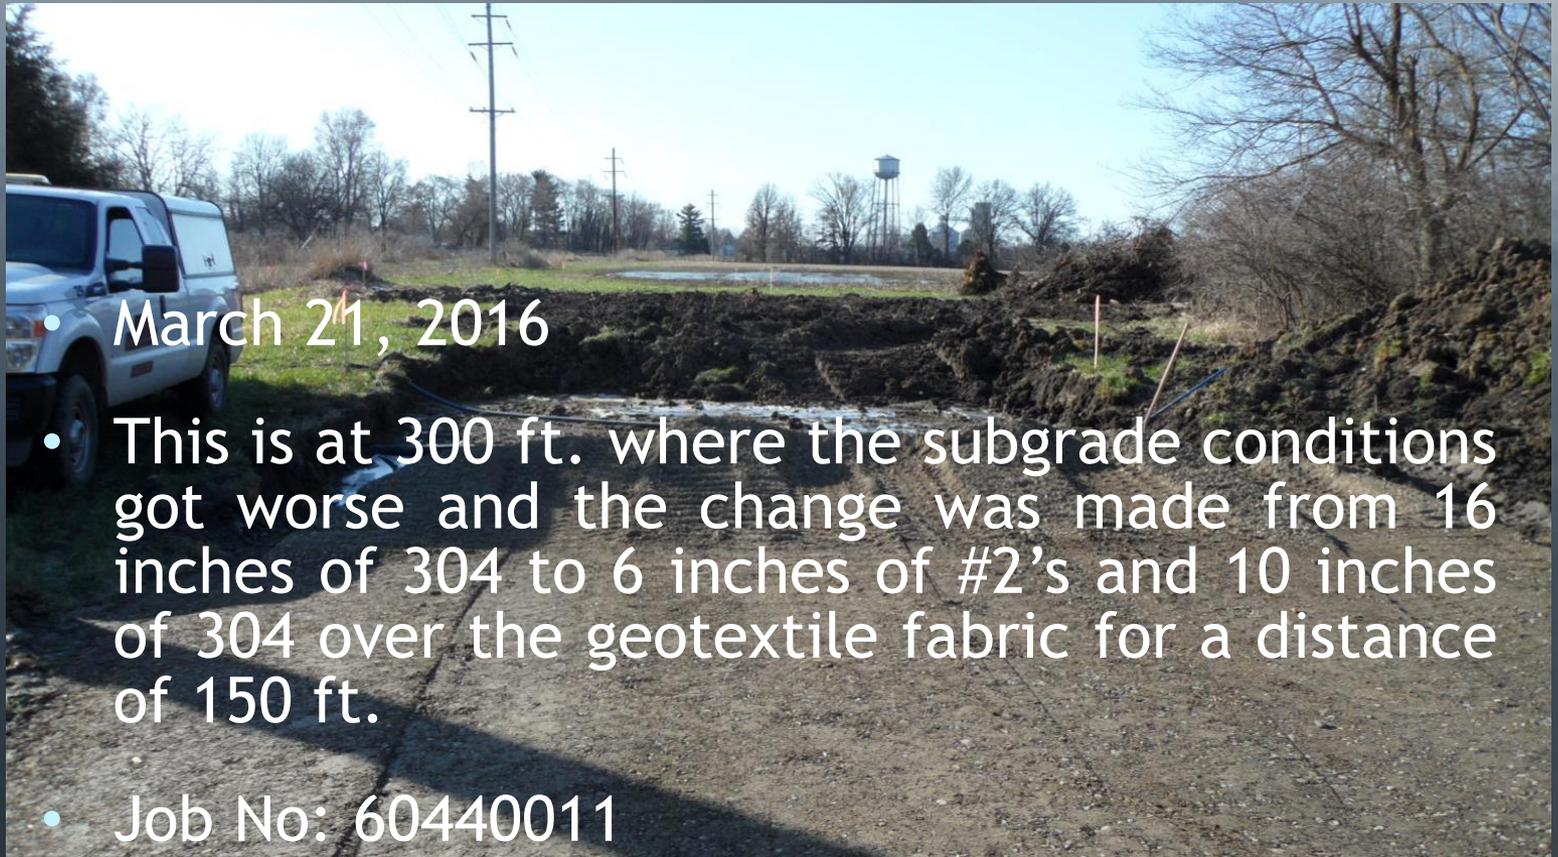
- March 21, 2016
- This is at 300 ft. where the subgrade conditions got worse and the change was made from 16 inches of 304 to 6 inches of #2's and 10 inches of 304 over the geotextile fabric for a distance of 150 ft.
- Job No: 60440011

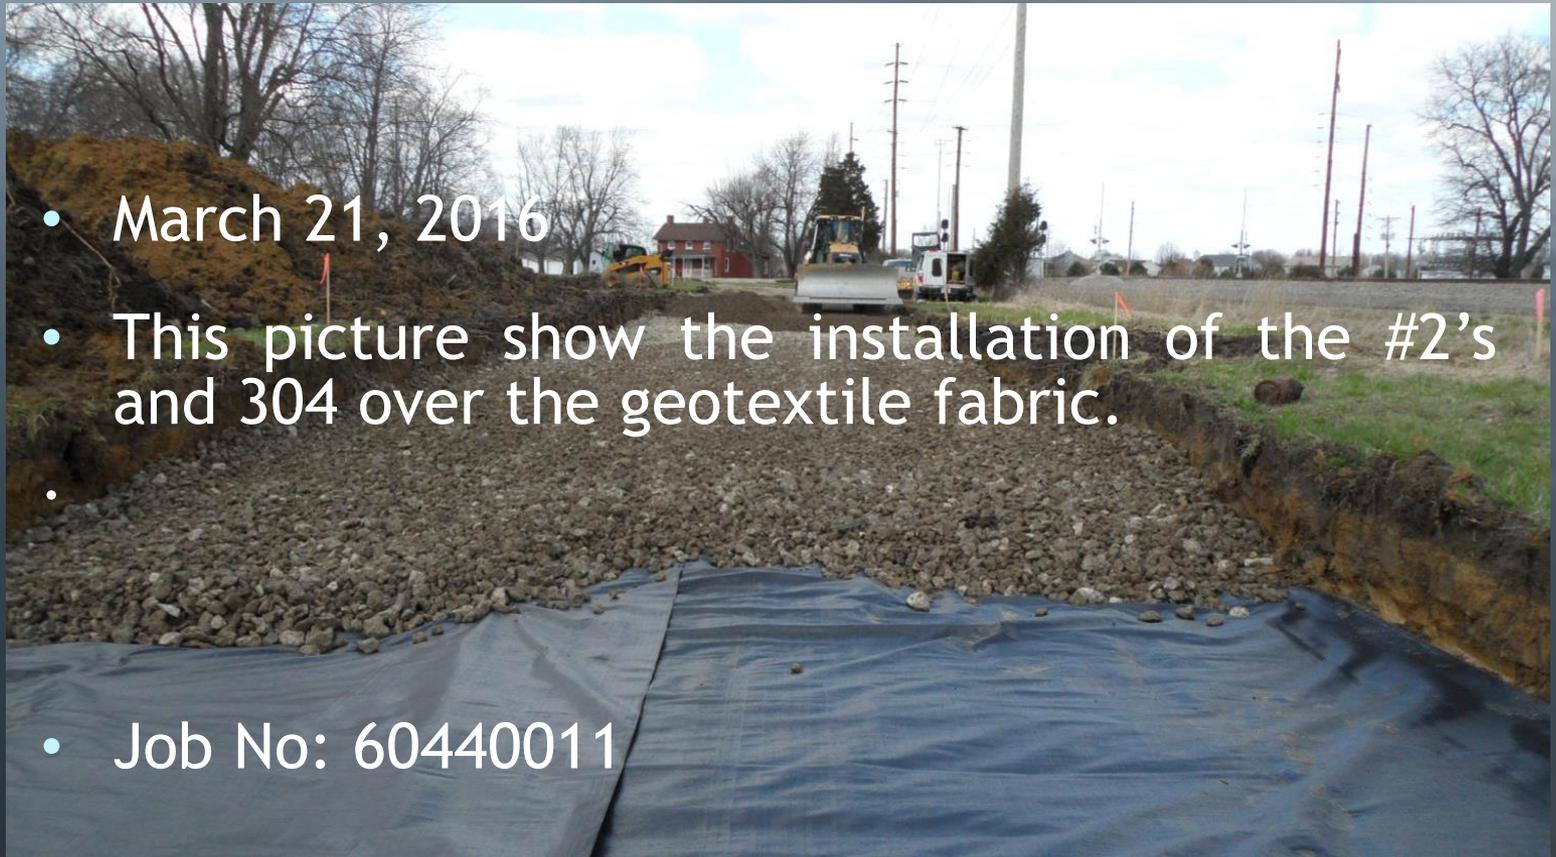
- March 21, 2016
- This picture show the installation of the #2's and 304 over the geotextile fabric.
-
- Job No: 60440011

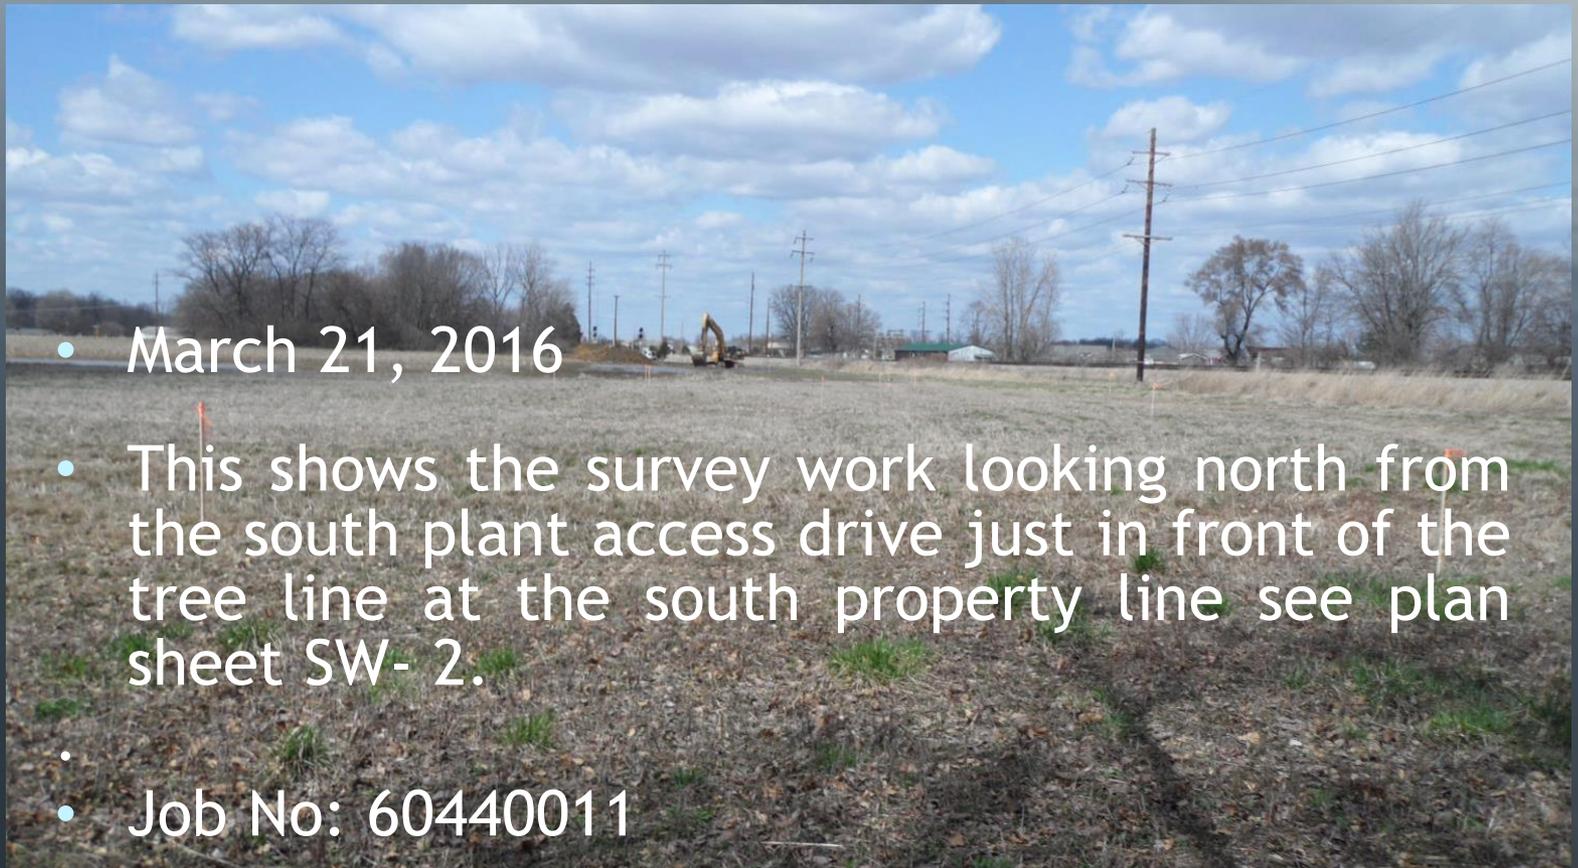
- March 21, 2016
- This shows the survey work looking north from the south plant access drive just in front of the tree line at the south property line see plan sheet SW- 2.
- Job No: 60440011
